Re: Physical Inspection of Birchwood Apartments

Date: January 25, 2023  
To: Eric Siebens, Midwest Regional Director  
Cheryl Halvorson, Midwest Acting Team Lead – Team 6  
From: Diann Carlson, Loan Specialist  
Re: Physical Inspection of Birchwood Apts.,

On January 24, 2023, I inspected Birchwood Apartments in Grand Marais, MN. These are my comments per unit/common areas:

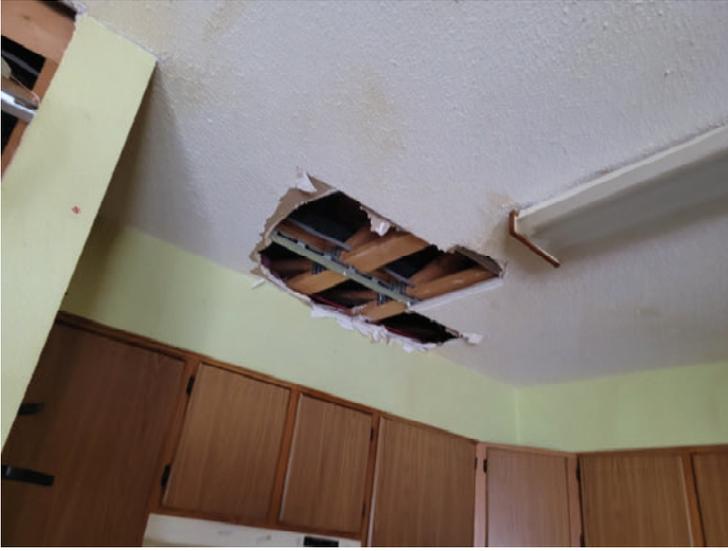
PIN-HOLE LEAK IN CEILING  
STILL DRIPPING WATER.

- Water damage:
    - Kitchen/living room/bathroom ceilings
    - Kitchen/living room/bathroom walls
    - Kitchen/living room/bathroom carpet/flooring
    - Water still leaking from bathroom ceiling due to pin-hole leak
